Pilothouse console of M/V J. W. WESTCOTT II after salvage. Photo taken on October 29, 2001.

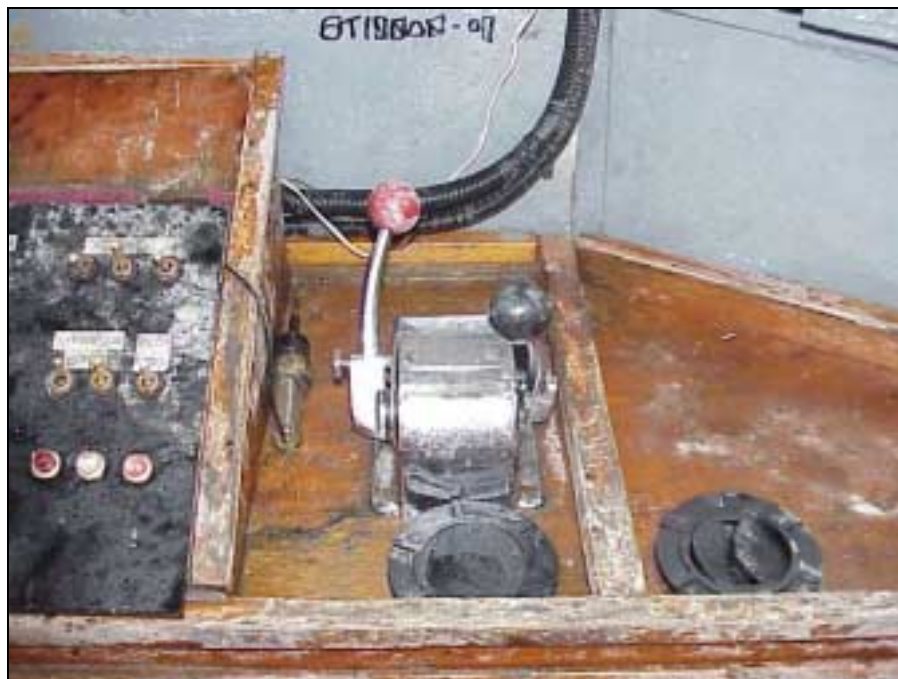
Throttle (left) and transmission (right) controls of M/V J.W. WESTCOTT II. Throttle is in "full" position. The transmission control is in between neutral and astern. Photo taken on October 29, 2001.

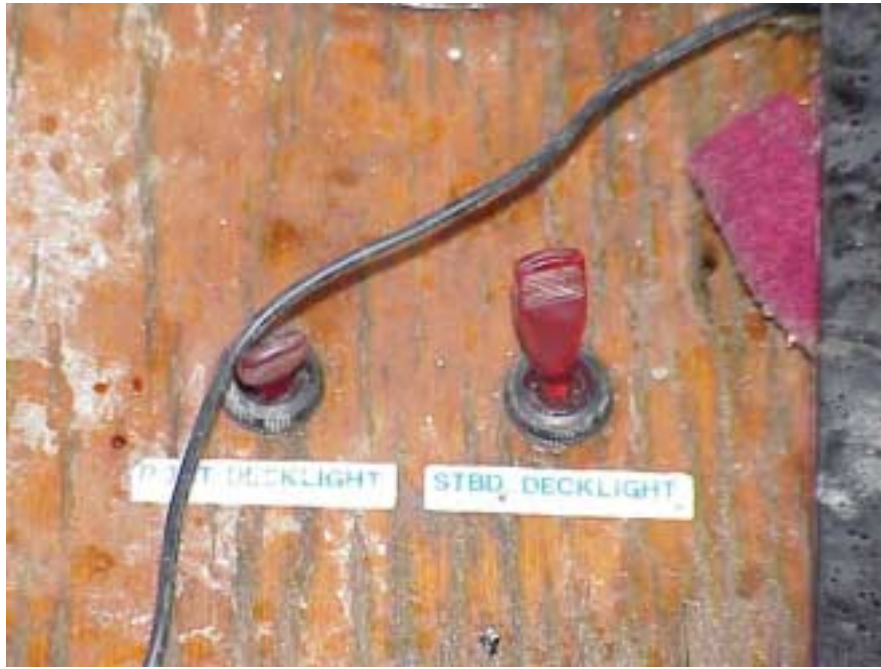
Deck light control switches on M/V/ J.W. WESTCOTT II. Port deck light switch is “off.” Starboard deck light switch is “on.” There are the normal switch positions when conducting a starboard side transfer. Photo taken on October 29, 2001.

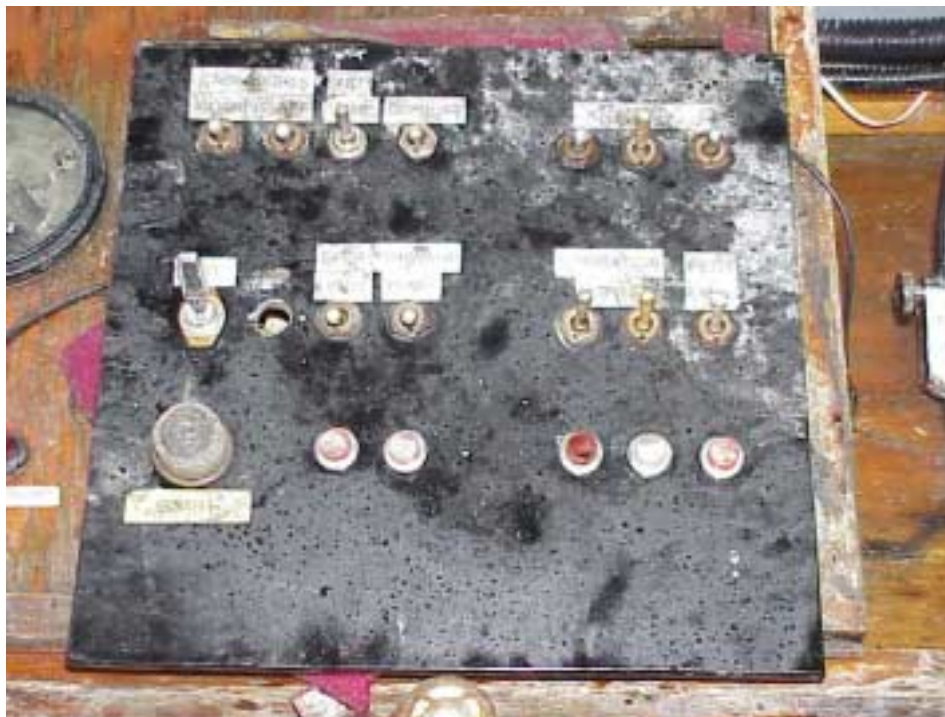
Light switch console on M/V J.W. WESTCOTT II. All switch positions are considered normal for transferring pilot at night. Photo taken on October 29, 2001.
